WAR DAMAGE REPORT No. 33

U.S.S. STERETT (DD407)

Gunfire Damage

Battle of Guadalcanal

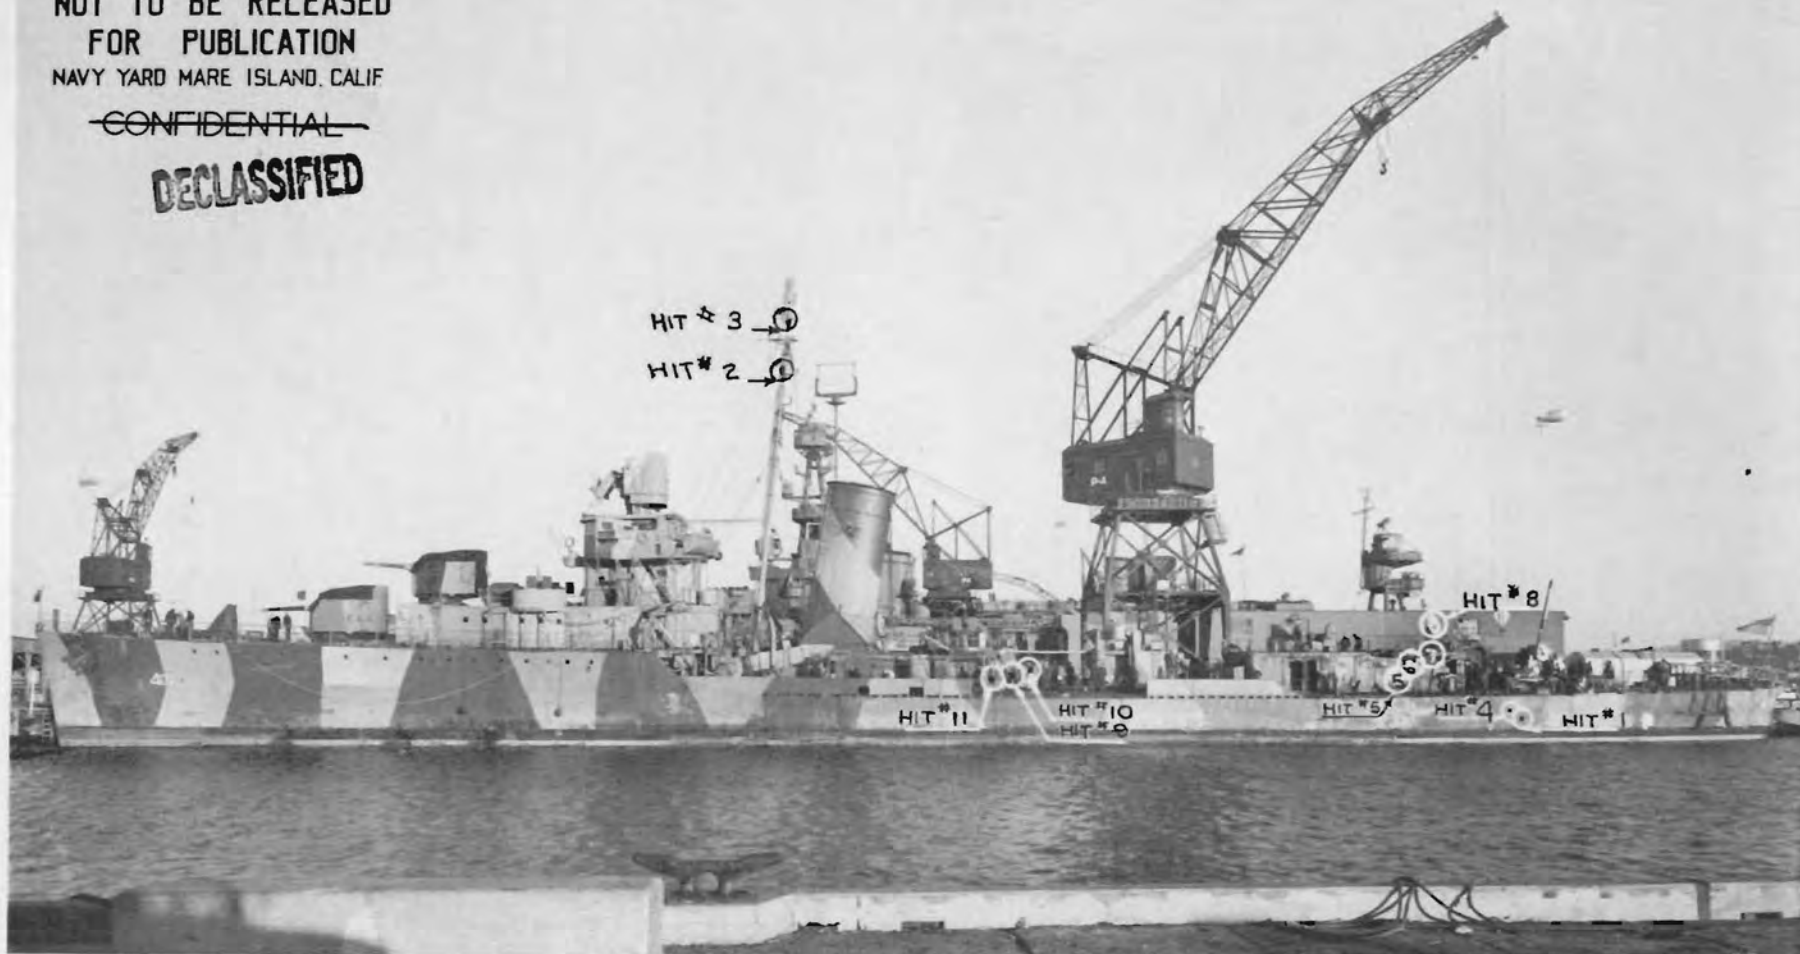
8. All hits were received on the port side above the waterline, located roughly in two groups: one amidships and the other aft. All projectiles were believed to have been of the common type and fired from ranges of 3,000 to 4,000 yards with relative bearings from 230° to 300°. Hit No. 1 was received at 0151, hit No. 2 at 0205 and hits Nos. 3 through 11 were received at 0227.

Photo 1: Outboard port profile showing location of projectile hits.

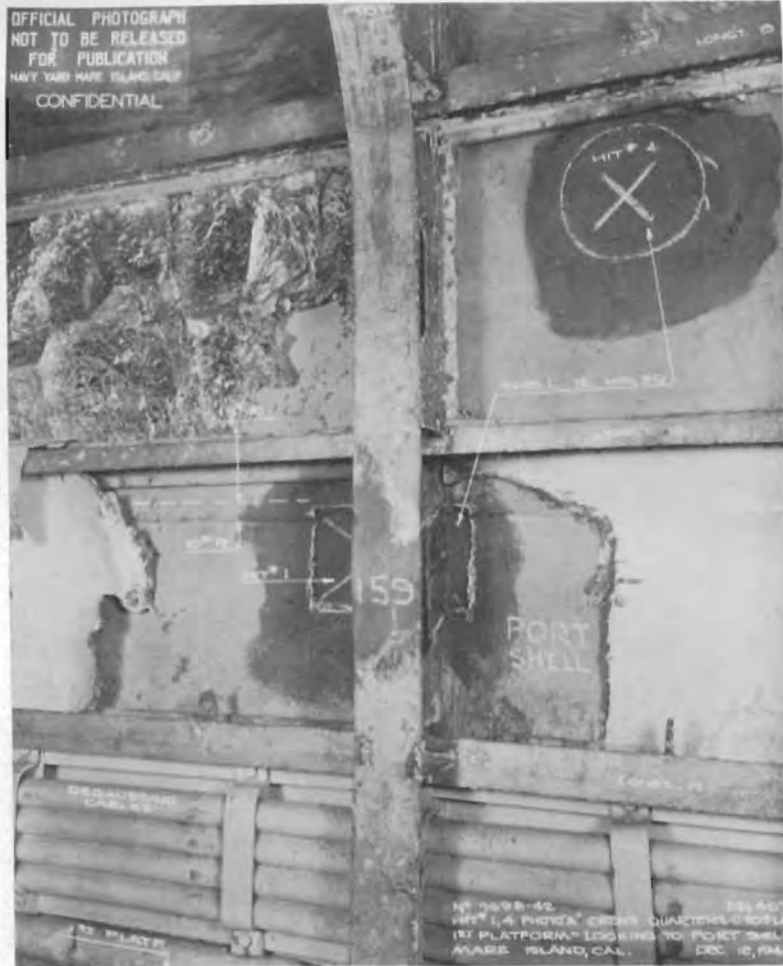
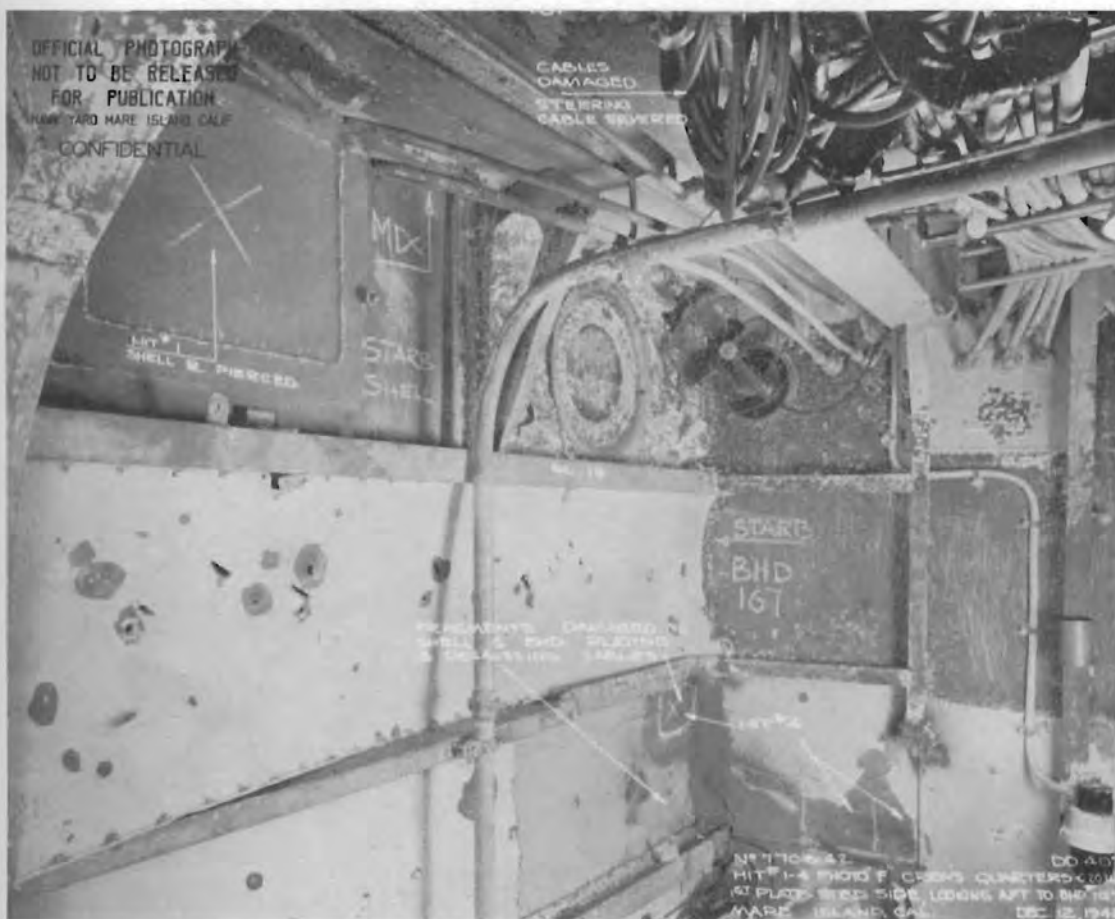
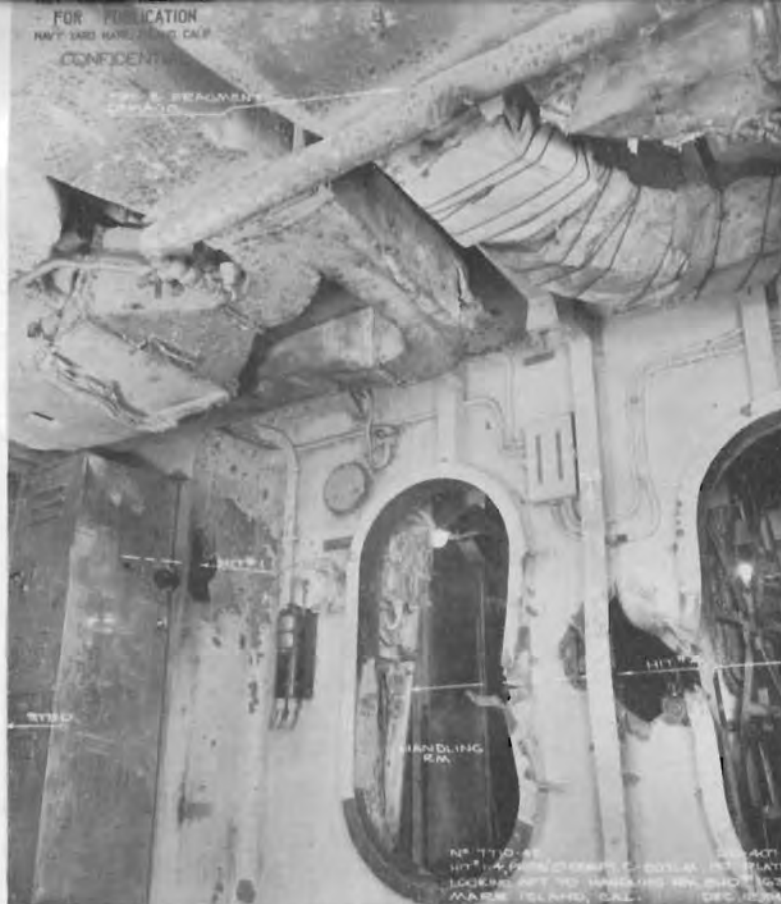
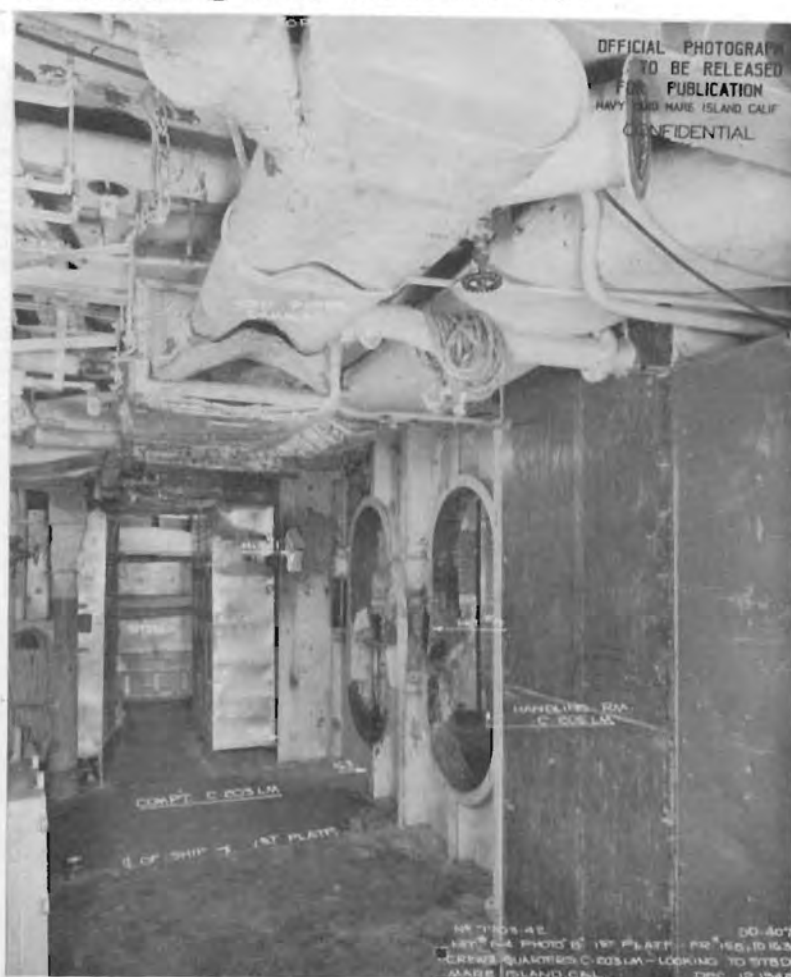
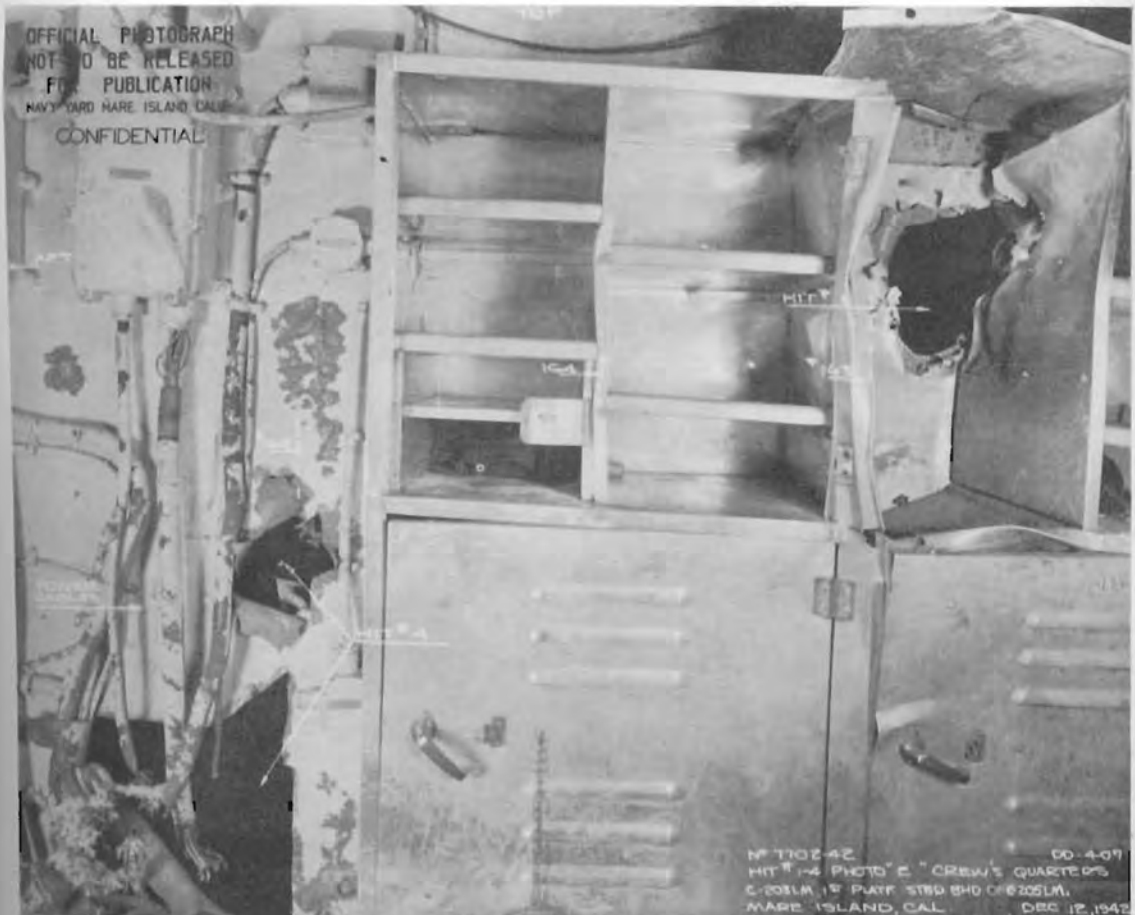
9. Hit No. 1 (Photos 2 to 7 inclusive), estimated to have been a 4" projectile, pierced the 10 pound port shell plating abaft web frame 159 about five feet below the main deck. Because of delayed action or a faulty fuze, this projectile failed to detonate. It passed through bunks and lockers in the crew's quarters (compartment C-203-LM) and bulkheads bounding the ready stowage of gun No. 4 handling room, finally exiting through the starboard shell at frame 164 about one foot below the main deck. Several minor fires were started. Fragmentation of damaged structures shattered ventilation piping and equipment. Electrical circuits sustained extensive damage from fragments and subsequent fires. An entire group of cables on the starboard overhead, including the starboard steering motor cable and various communication and power circuits, were either severed or so badly torn and burned that they could not be used. Steering control was shifted to the port steering motor cable; however, the rudder jammed momentarily, necessitating steering by the engines.

11. Hit No. 4 (Photos 2 to 7 inclusive), estimated to have been a 4" projectile, pierced the port shell plating between frames 158 and 159 about two feet six inches below the main deck. It then passed through bunks and lockers in crew's quarters (C-203-LM), shattered the centerline support and archways of gun No. 4 handling room bulkhead at frame 163, continued on, piercing the starboard handling room bulkhead at frame 165 and finally expending itself with the distortion of the starboard plating and stiffeners on bulkhead 167. Fragments made several small holes in the starboard shell in the vicinity of frame 167. Detonation was of low order and caused minor fragment damage; however, large splinters from the fragmentation of the handling room archway and other structures flew in almost every direction, some piercing the starboard shell at frame 165 three feet above the waterline. Fragments also pierced the handling room bulkhead and power panels at the bottom of gun No. 4 center column and severed gun No. 4 power cables and the degaussing cable. Ammunition hoist equipment of gun No. 4 was also damaged by fragments. Fragments struck six ready service powder tanks and ignited the powder causing a bad fire.

24. As a result of hit No. 1, several minor fires were started in compartment C-203-LM; and while information is not available as to what was burning, it is assumed that personal gear in lockers and bedding were ignited by hot structural fragments. Before damaged electrical circuits were deenergized, it is probable that there were several electrical fires. All fires from this first hit, however, were extinguished before hit No. 4 was received in the same compartment 14 minutes later and which resulted in additional fires. These latter fires were very persistent and most difficult to extinguish inasmuch as they were aggravated by the ignition of six 5" ready service powder charges.

Photo 2: Hits No. 1 and No. 4 first platform crew's quarters C-203-LM looking to port shell.

Photo 3: Hits No.1 and No. 4 first platform crew's quarters C-203-LM looking to aft and starboard shell.

Photo 4: Hits No. 1 and No. 4 first platform crew's quarters C-203-LM looking aft to handling room bulkhead 163.

Photo 5: Hits No. 1 and No. 4 first platform crew's quarters C-203-LM looking to starboard

Photo 7: Hits No. 1 and No. 4 first platform crew's quarters C-203-LM.

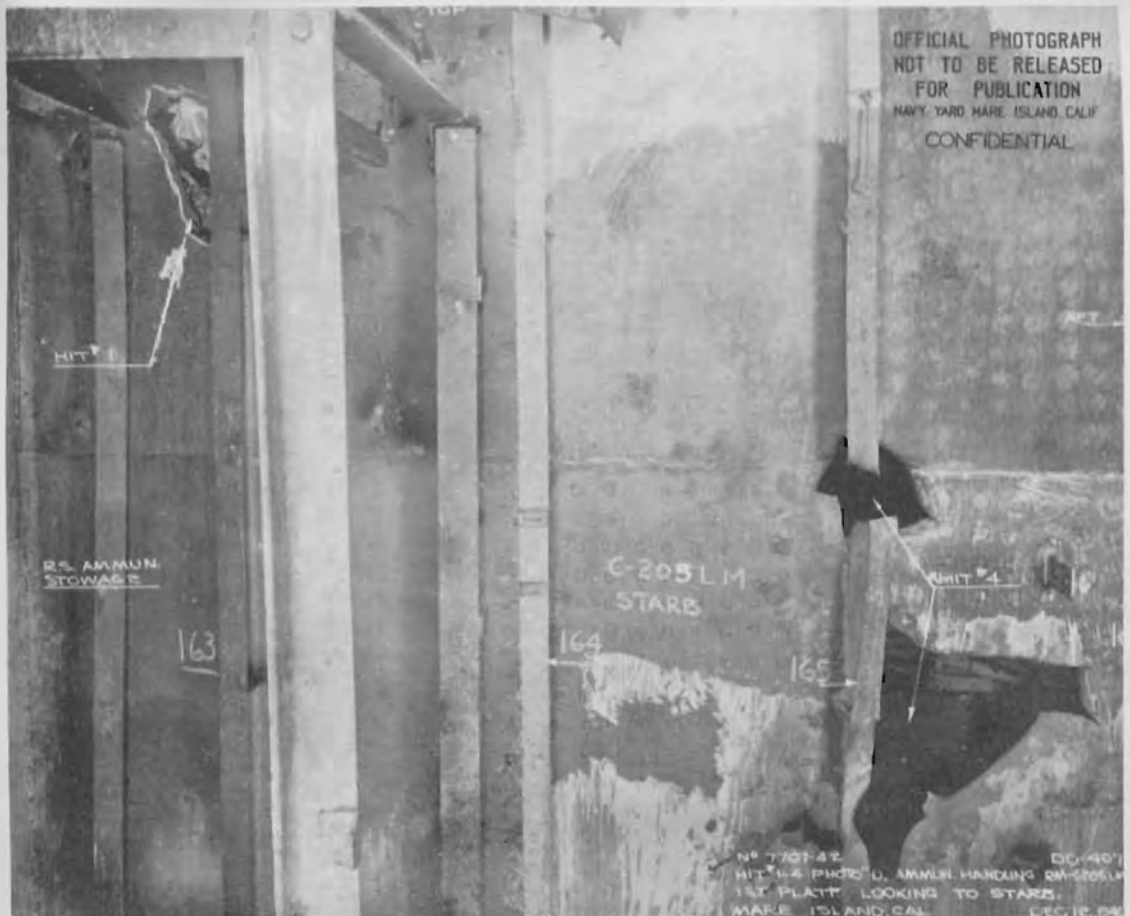
27. Some charges of 5" powder in handling room C-205-LM were ignited by structural fragments resulting from hit No. 4. It was apparent that the charges in these tanks burned with an intense flame but there were no indications of an explosion. In the ready service stowage compartment for No. 3 gun in the after deck house, a relatively confined space, six powder charges were ignited by projectile fragments and burned with such violence that aluminum bulkhead 154 was somewhat distorted. The steel bulkhead at frame 152-3/4, however, was not distorted which would indicate that the resulting explosions, if the violent fires can be classed as such, were of a minor character.

Photo 6: Hits No. 1 and No. 4 first platform ammunition handling room C-205-LM looking to starboard.

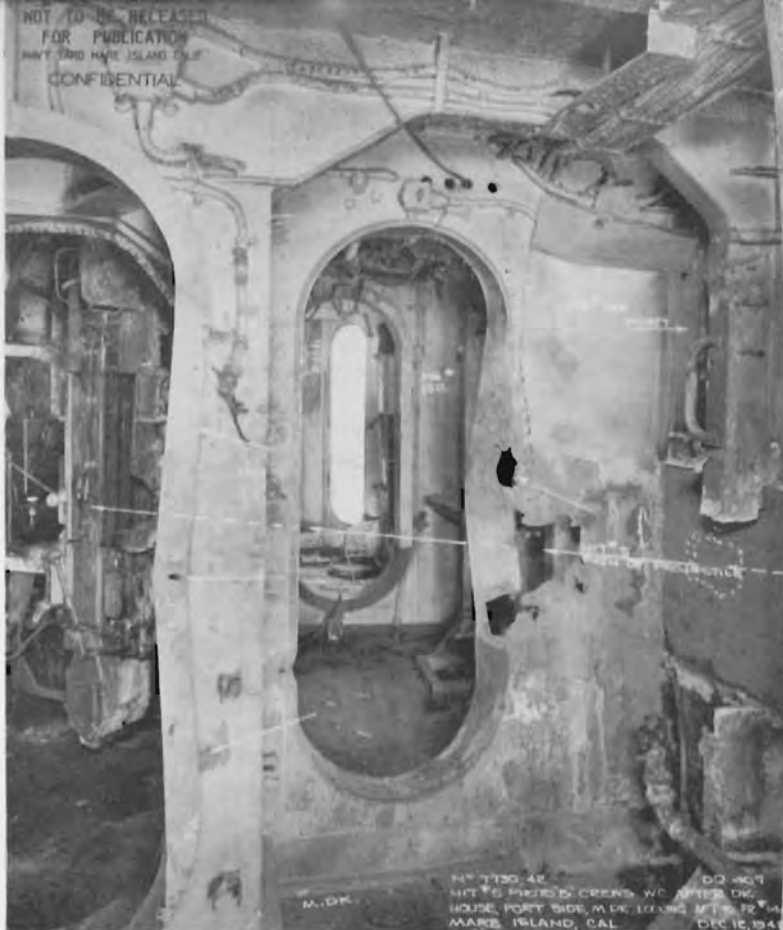
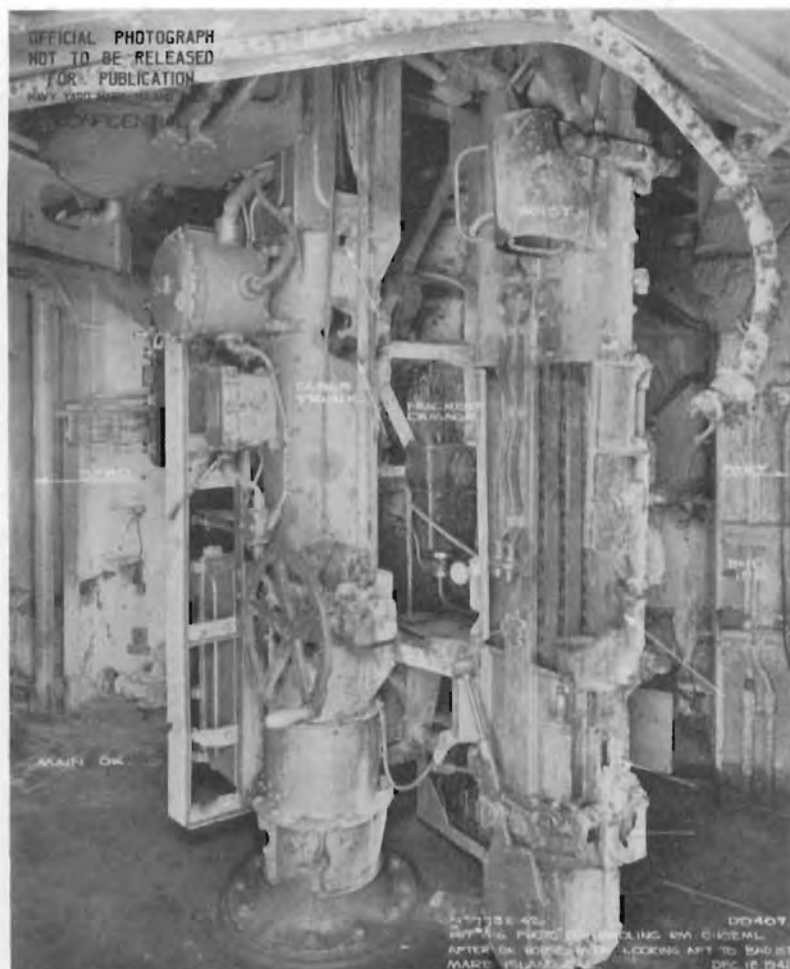
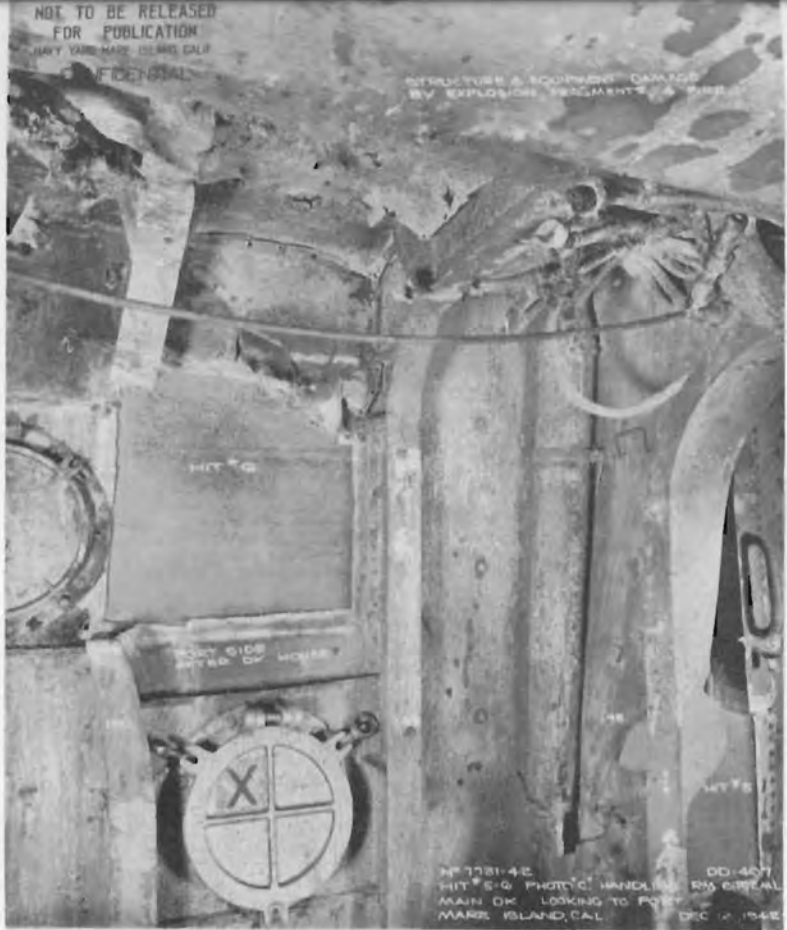
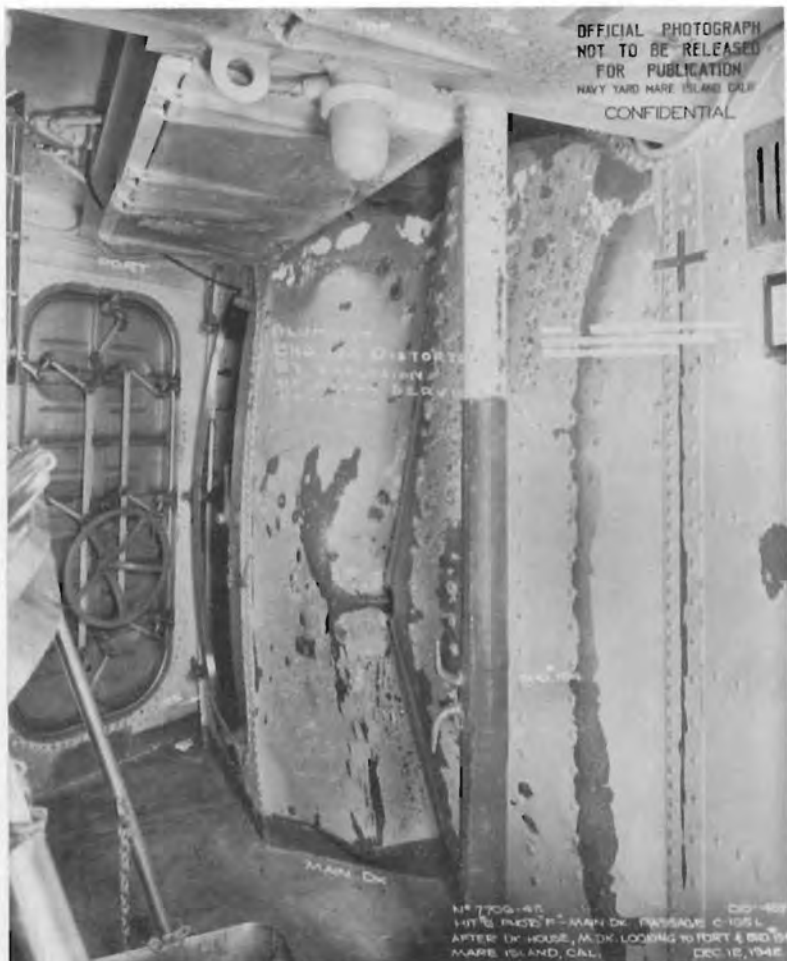
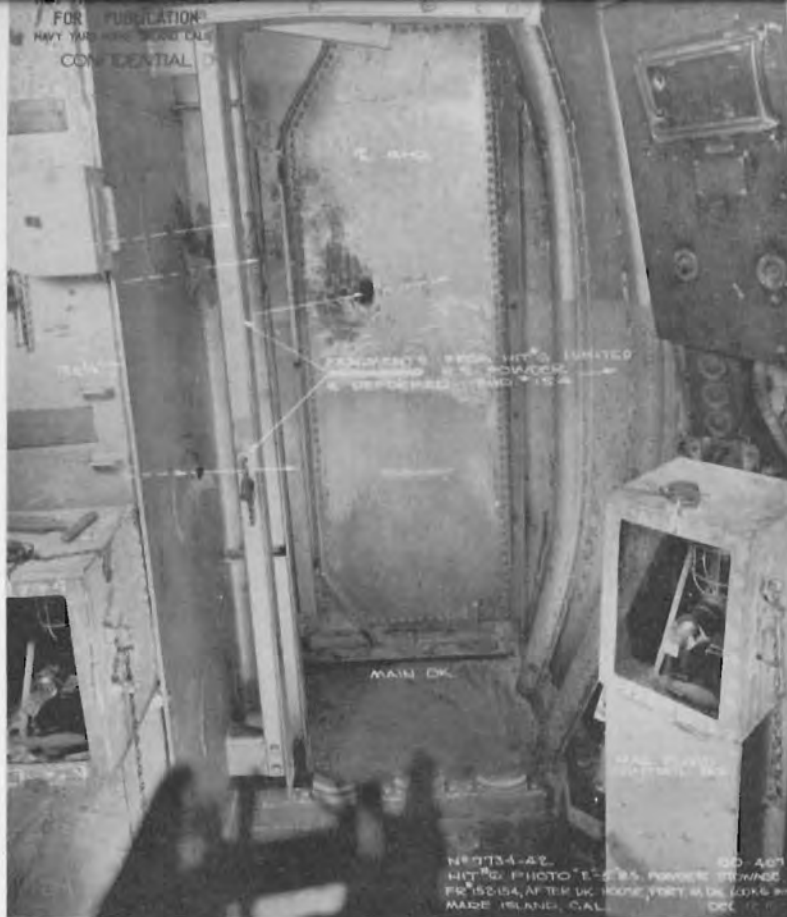
13. Hits Nos. 5, 6 and 7 (Photos 8 to 13 inclusive), estimated to have been of medium caliber, were received on the port side of the after deck house at about the same time and within a small area. Each projectile detonated upon impact and the resulting damage was confined mainly to compartment C-102-LM and structures immediately adjacent. Hit No. 5 blew a hole about 15 inches in diameter between frames 147 and 148 three feet above the main deck; hit No. 6 formed a hole about six inches in diameter between frames 149 and 150 some five feet above the main deck. Hit No. 7 shattered the coaming and deck plating of the after deck house. The force of these explosions and fragments tore large pieces from the handling room doorway frame, pierced the center gun column and projectile hoist and severed power cables. Fragments also penetrated and buckled deck longitudinals and bulkheads of the handling room and other structures as far as 15 feet from the point of impact. Several ready service powder tanks were pierced by fragments and ignited causing a severe fire. The shield and roller path of gun No. 3 were damaged by fragments.

Photo 8: Hit No. 5 main deck port side after deck house looking aft to frame 148.

Photo 9: Hits No. 5 and No. 6 main deck handling room C-102-ML after deck house.

Photo 10: Hits No. 5 and No. 6 main deck handling room C-102-ML looking to port.

Photo 11: Hit No. 6 main deck passage C-105-L after deck house.

Photo 12: Hit No. 6 main deck 5" ready service stowage.

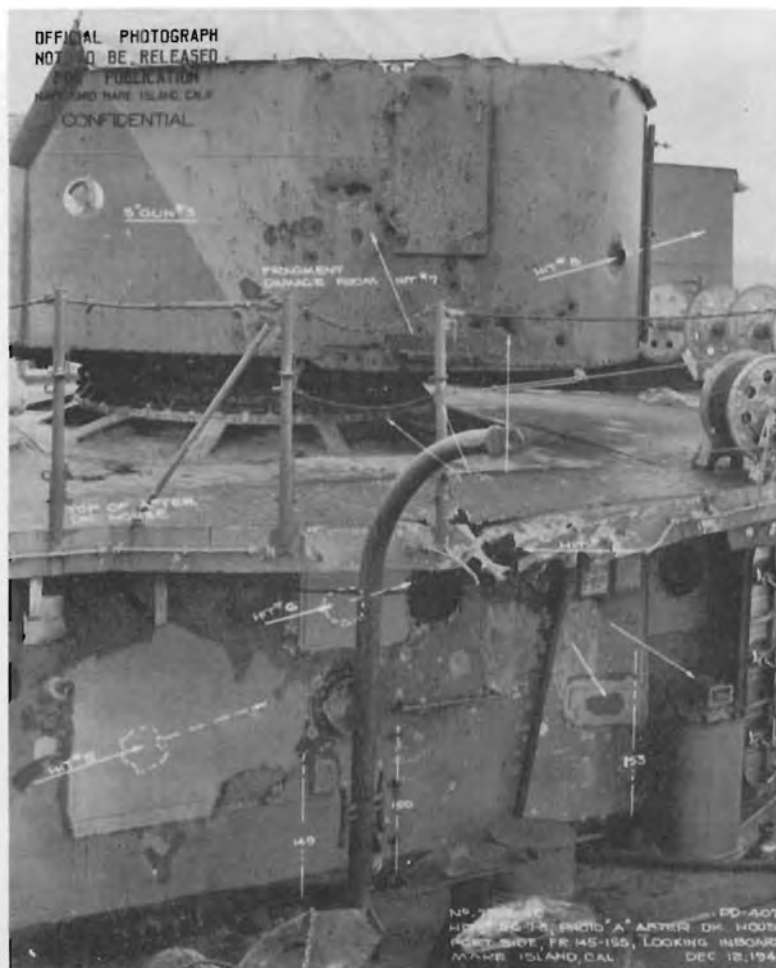
14. Hit No. 8 (Photos 13 and 14), estimated to have been a 4" projectile, pierced the left after end of the shield on gun No. 3, passing on through the right side without detonating.

Photo 13: Hits No. 5, 6, 7 and 8 after deck house port side looking inboard.

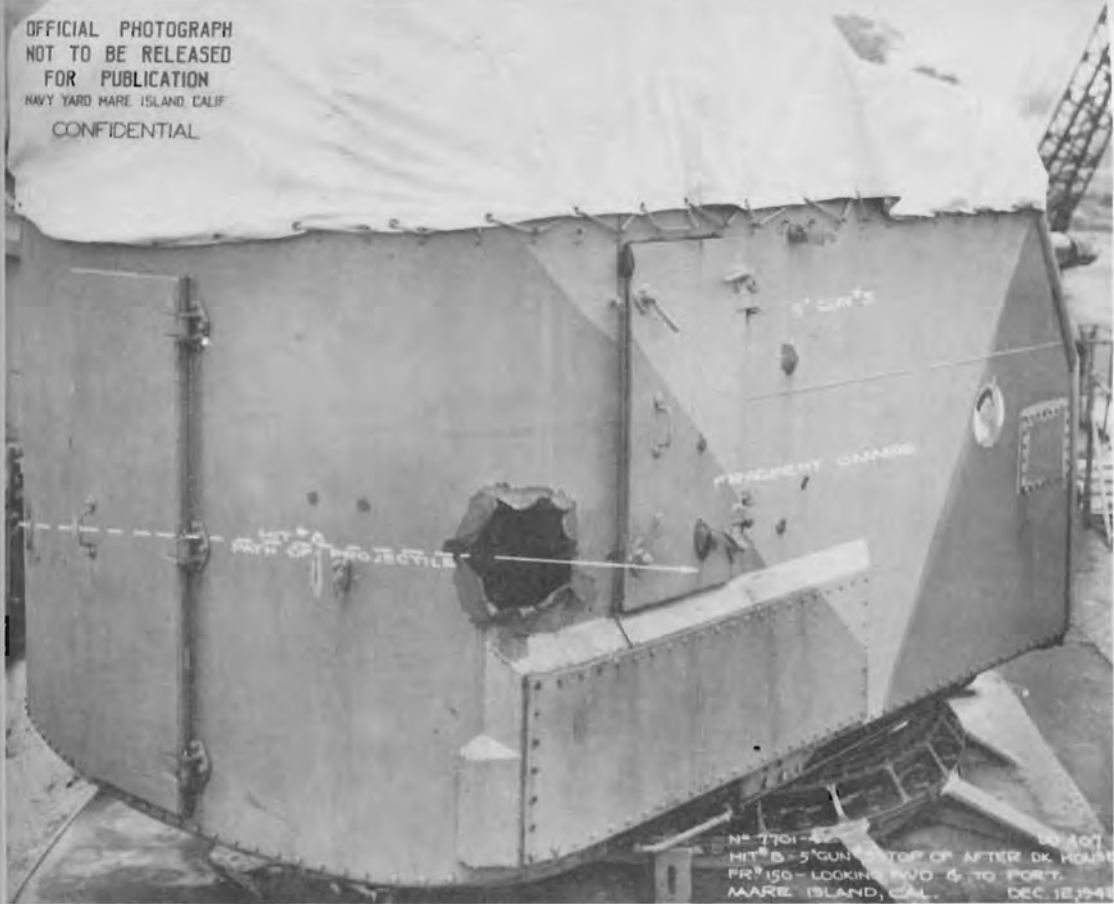
Photo 14: Hit No. 8 gun No. 3 top of after deck house looking forward and to port.

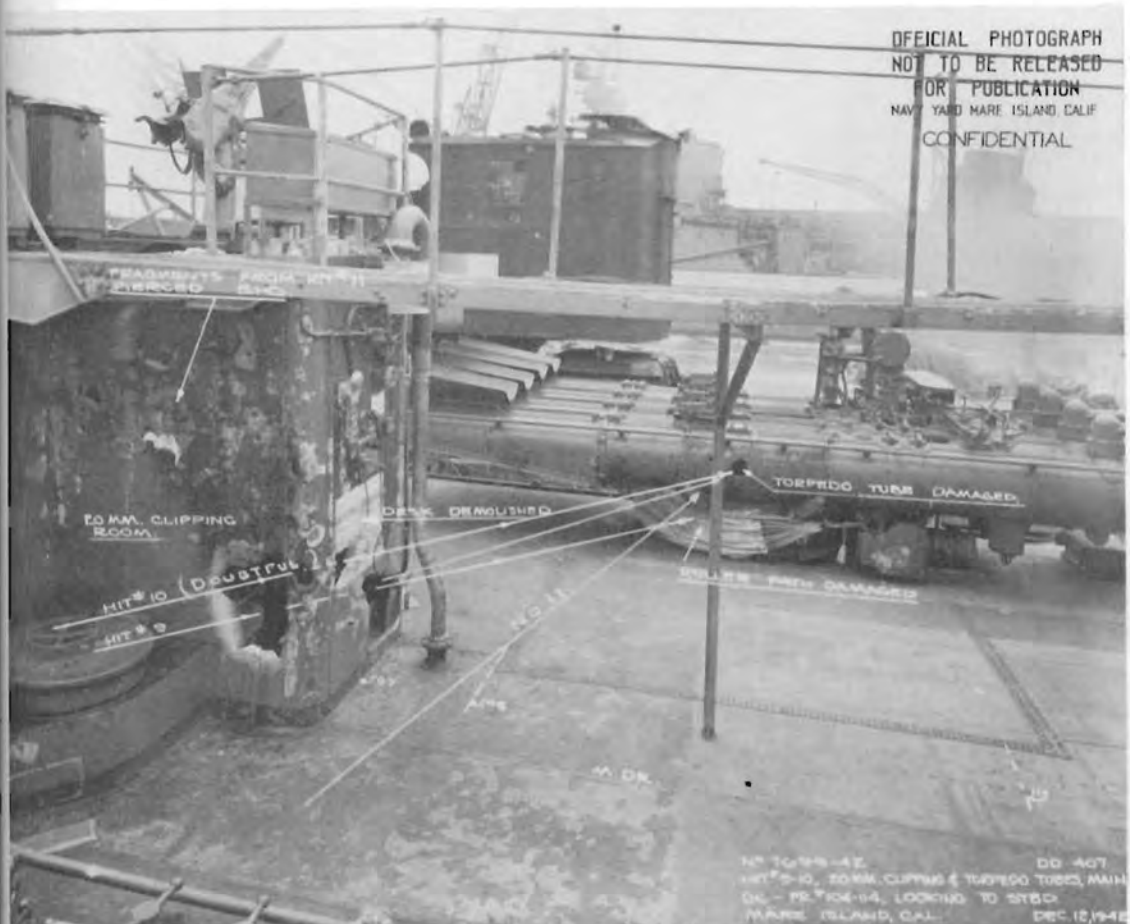
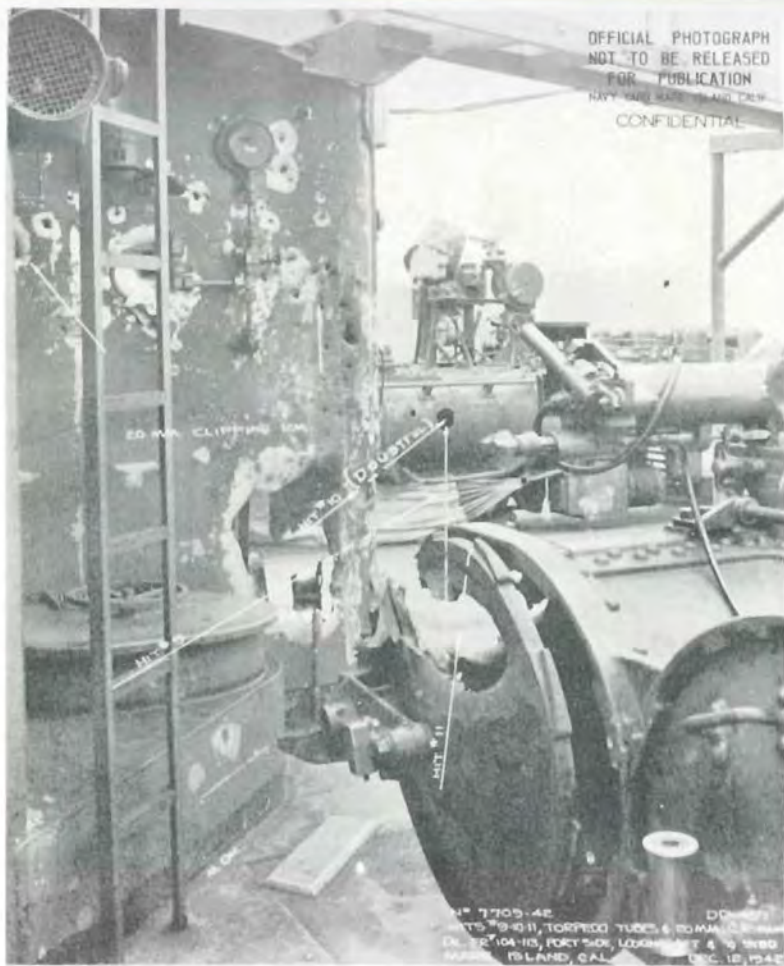
15. Hits Nos. 9, 10 and 11 (Photos 15, 16 and 17), estimated by the Commanding Officer to have been 5" projectiles, detonated upon impact. The first struck the lower port corner of the 20mm clipping room amidships on the main deck, the second apparently hit the officer of the deck's desk on the after bulkhead of the same clipping room and the third detonated at the after end of the left barrel of the port torpedo tubes. From photographs of structures in this area, however, it is not very clear as to the individual damage from each separate projectile, and it is conjectural as to whether there were three hits or only two. The resulting damage will be treated collectively. A hole approximately 14 inches in diameter was blown in the port bulkhead of the clipping room and sections of the after and starboard bulkheads were holed. Fragments, which spread in all directions, severed sprinkling pipes and caused 20mm ammunition to explode starting fires which resulted in the distortion of the entire clipping room. The desk and shield were demolished. The loading door of the left barrel of the port torpedo nest, which was empty at the time, was penetrated resulting in a hole about five inches in diameter. Fragments pierced the side walls and cracked the roller path shield of this tube. The starboard torpedo nest was damaged by fragments as follows: the side wall of barrel No. 4 was pierced and dented; the air flask of the torpedo in No. 4 tube was penetrated; the depth setting mechanism was shattered; a hole was cut in the training shaft housing; the teeth of the training arc were broken off and the roller path shield carried away; the trainer's seat was shattered; the saddle was damaged; the main indicator rod distorted and the firing buzzer cables carried away.

29. The charged air flask in the No. 4 tube of the starboard torpedo nest was pierced by fragments, (Photos Nos. 15 and 16). Reference (a) reported this fact but did not give any information as to the reaction of the air flask. Upon referring to the photographs, it is apparent that there was no resulting explosive reaction as might have been expected. The two holes shown in the tube apparently have been enlarged somewhat, presumably by the ship's company in smoothing the jagged edges to permit removal of the torpedo.

31. It is apparent in this case that the holes made in the flask were relatively small and that the air bled off slowly.

Photo 15: Hits No. 9 and No. 10 main deck, 20mm clipping room, starboard torpedo tubes.

Photo 16: Hits No. 9, 10 and 11 main deck looking aft and to starboard, 20mm clipping room, torpedo tubes looking aft and to starboard.

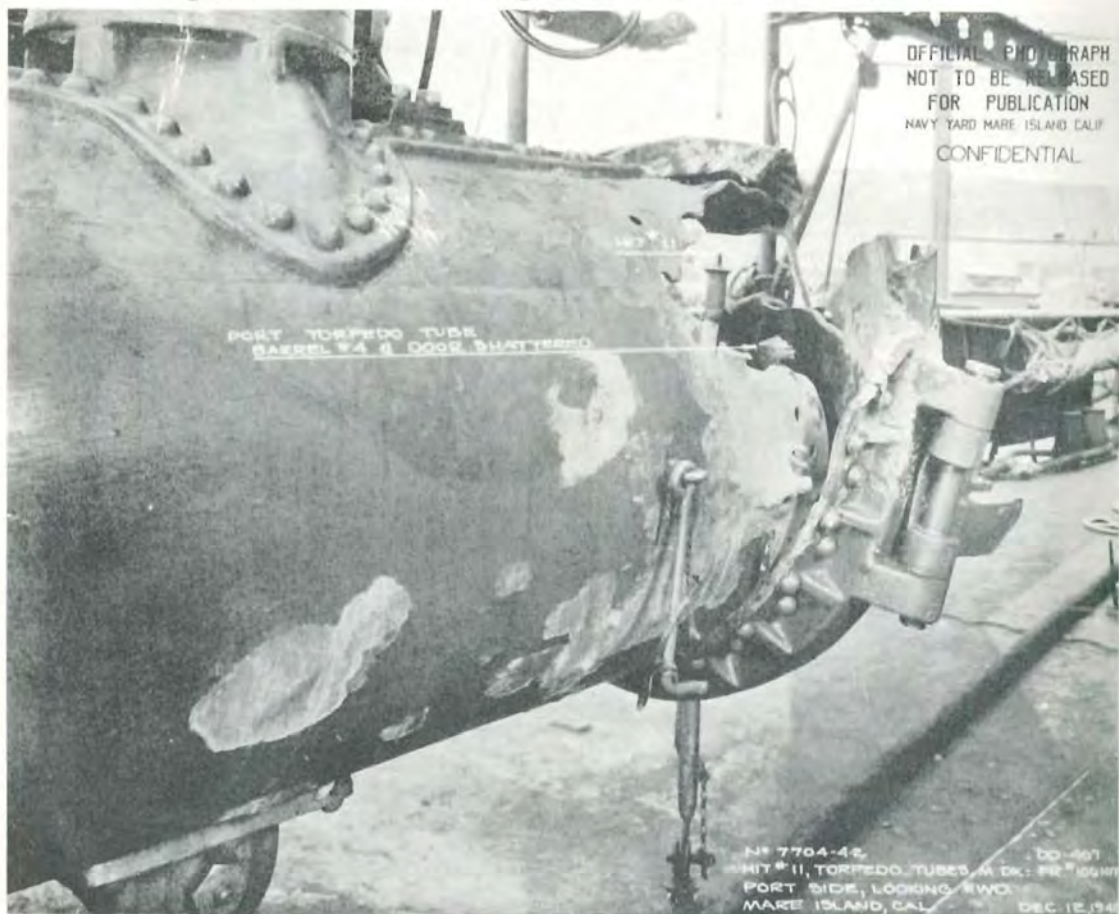
Photo 17: Hit No.11 main deck port torpedo tube.
